Inspection report

Nottingham Academy Primary and Secondary School Greenwood road site Nottingham NG3 7EB	Date Of Inspection:5.4.22
Responsible Person: Jo French, Rob Smith	Name Of Inspector(s): Sarah Ogburn, Billy Shaw, Geoff Slade
SEND Co: Isabelle Coulson (primary), Mrs S Scott (secondary)	Relevant Contacts: Helen Webster (H&S Contact), Martin Carrington (Site Manager), Carryanne Clulow(Safety/Employee Rep secondary), Simone Lineker(Safety/Employee Rep primary)

220405 NAC Accessibility Plan

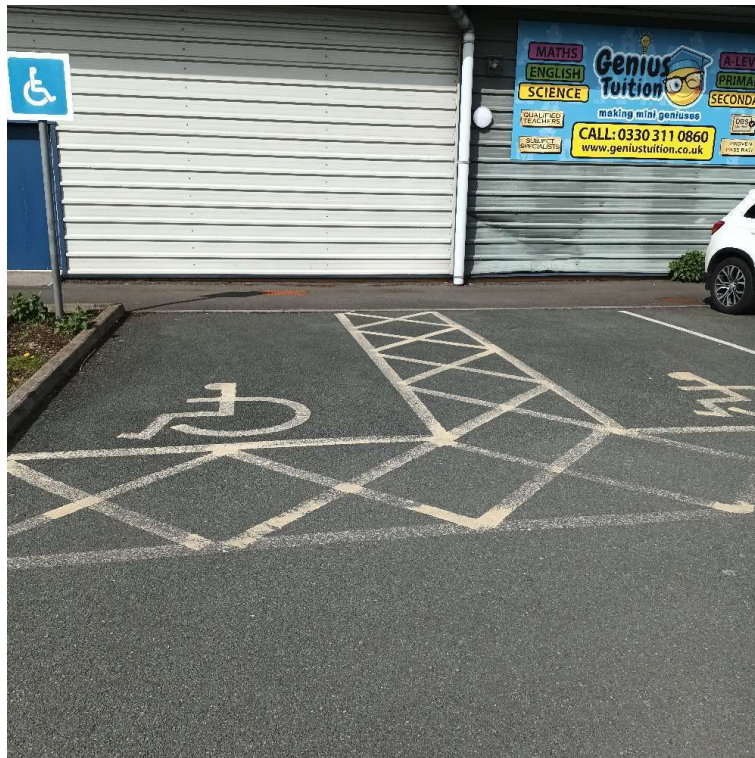
Disabled parking spaces incorrect size/ layout.

Modify existing disabled parking spaces to meet statutory requirements of 4800mm x 2400mm with 1200mm access space to end **and side/space**.

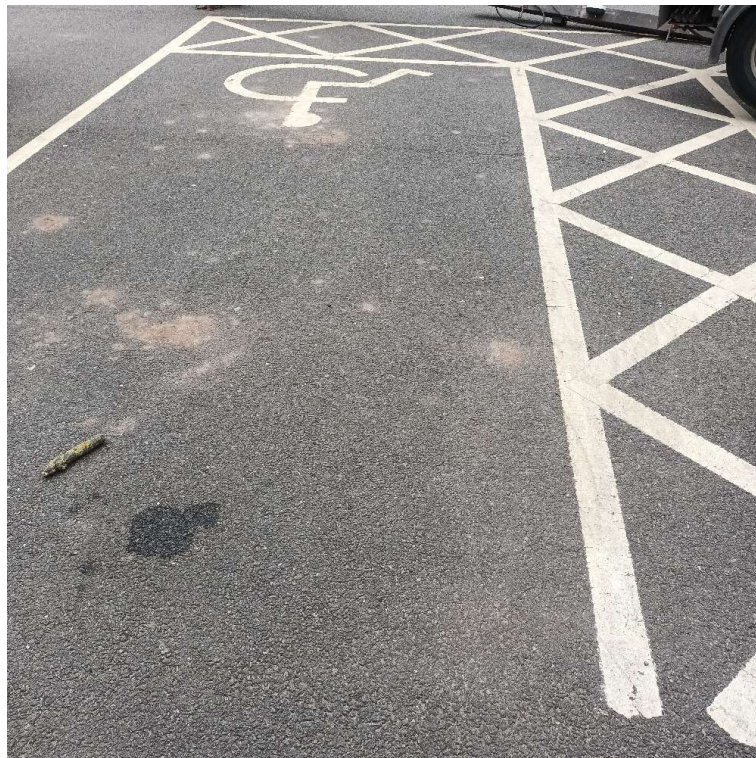
Only 2 disabled parking spaces.

Ensure 1 space/each disabled employee plus 5% of the visitor parking as disabled parking.

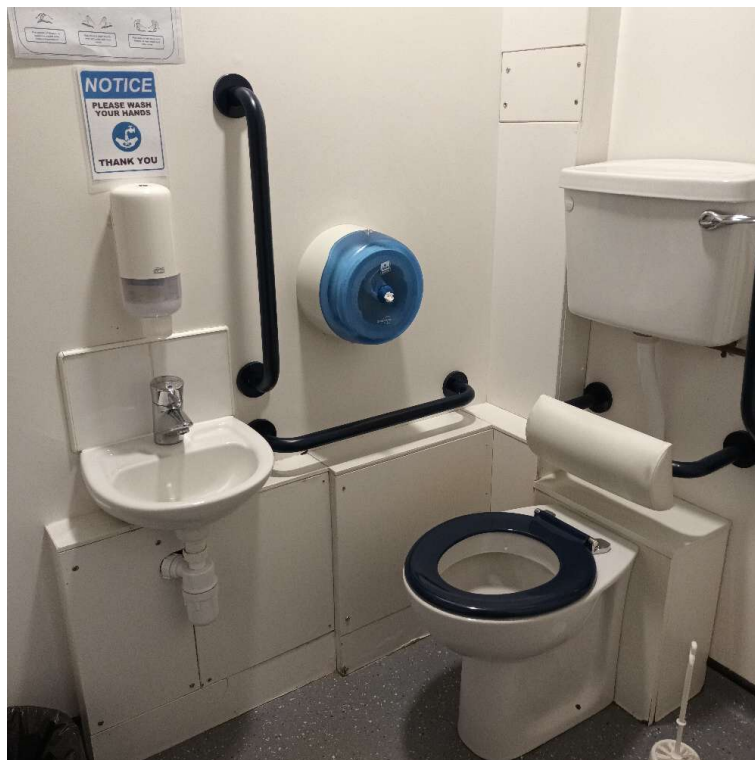
Fittings and consumables cannot be reached by person sitting on the toilet seat.

The sink, soap, toilet paper, and/or paper towels should be relocated to allow use whilst seated on the toilet.

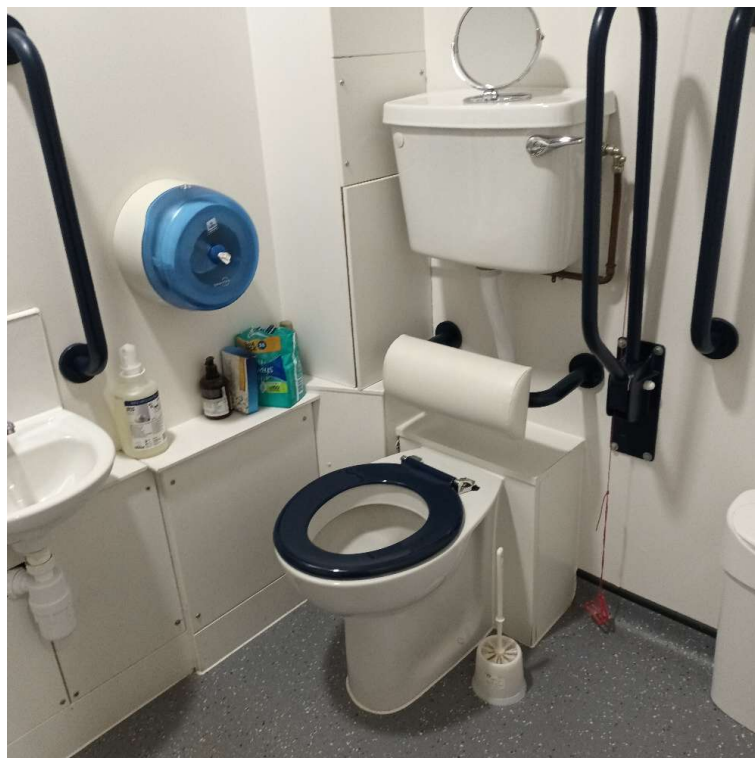
Fittings and consumables cannot be reached by person sitting on the toilet seat.

The sink, soap, toilet paper, and/or paper towels should be relocated to allow use whilst seated on the toilet.

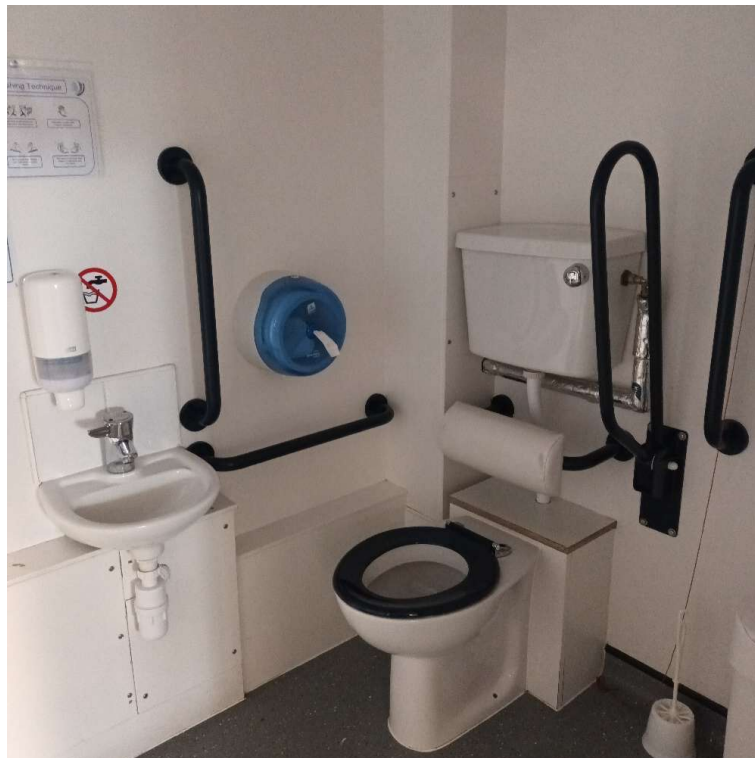
There is no visual alarm beacon to alert hearing impaired users.

Install a visual emergency beacon.

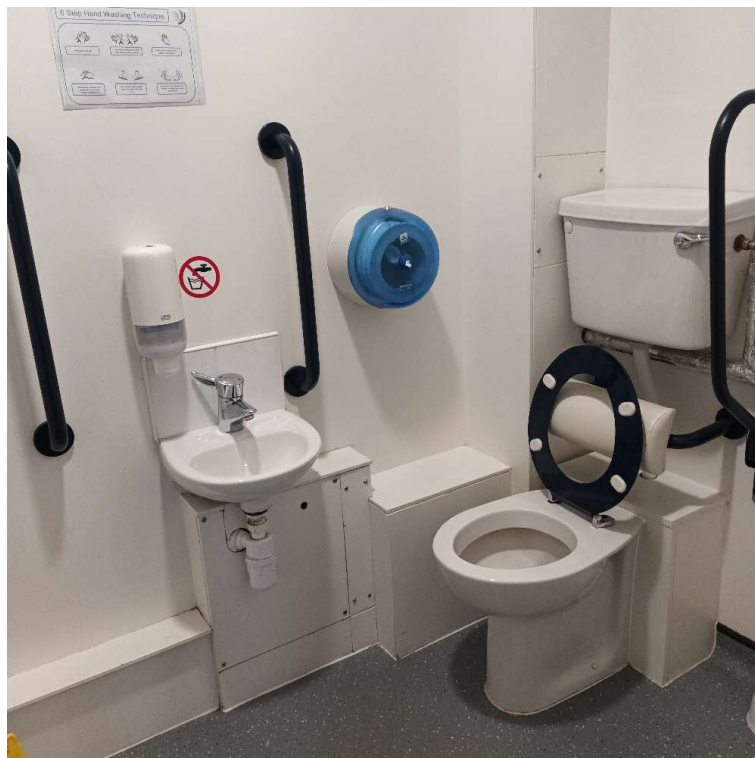
There is no visual alarm beacon to alert hearing impaired users.

Install a visual emergency beacon.

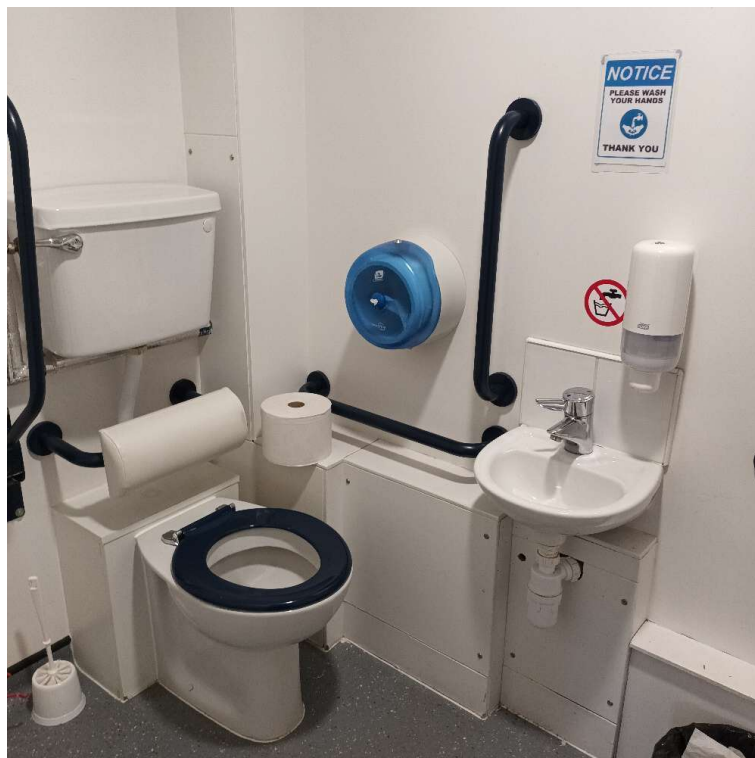
There is no visual alarm beacon to alert hearing impaired users.

Install a visual emergency beacon.

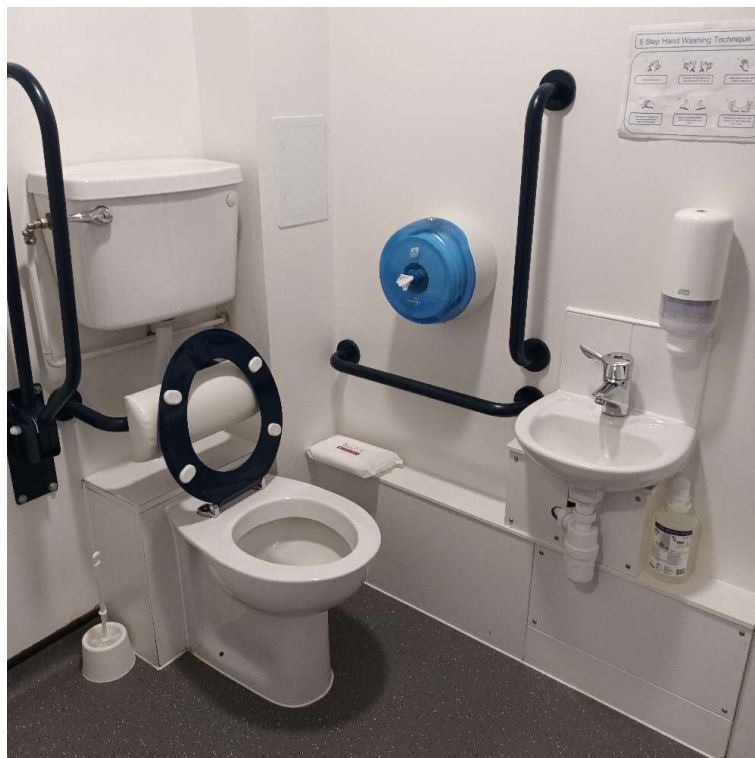
There is no visual alarm beacon to alert hearing impaired users.

Install a visual emergency beacon.

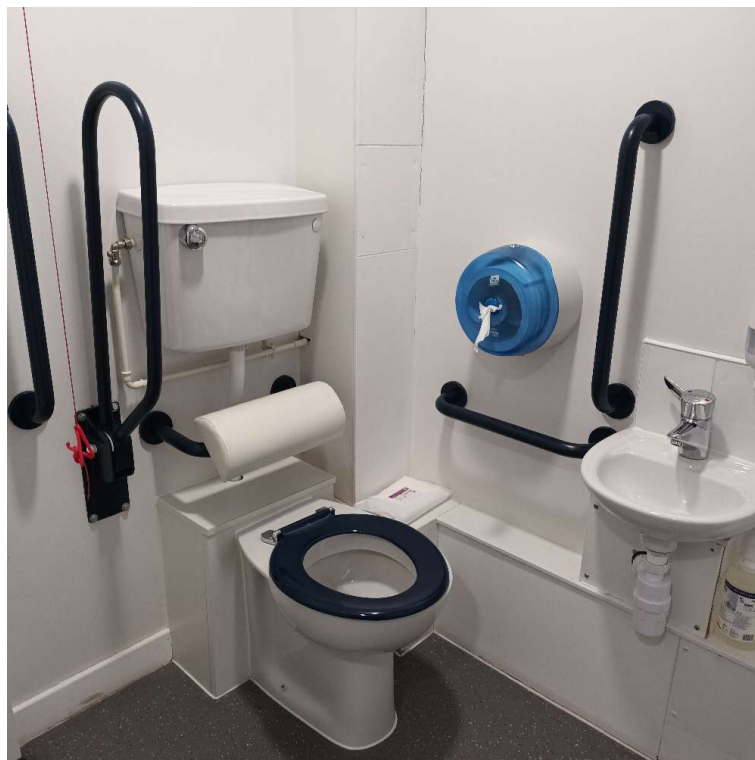
Fittings and consumables cannot be reached by person sitting on the toilet seat.

The sink, soap, toilet paper, and/or paper towels should be relocated to allow use whilst seated on the toilet.

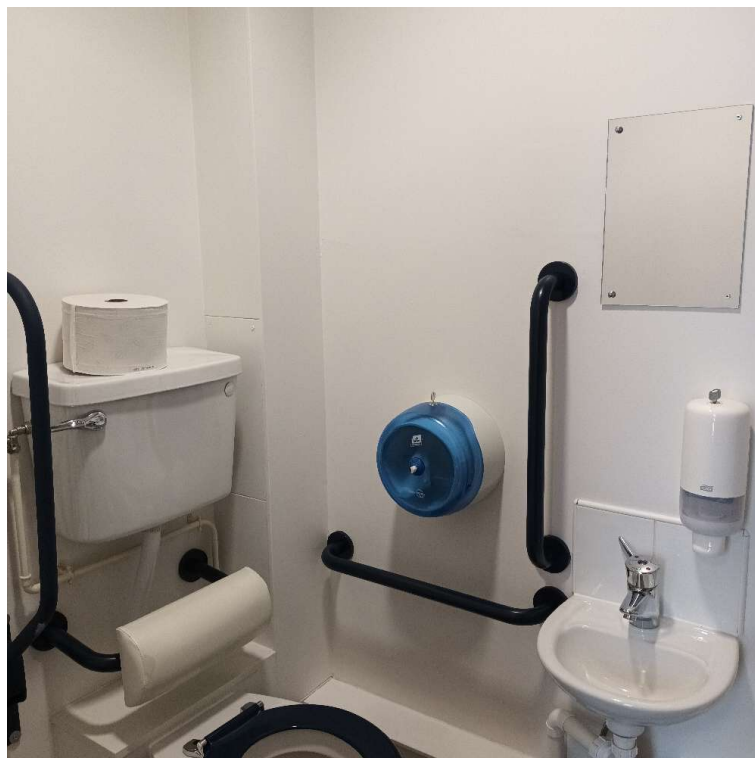
Emergency communication pull is not accessible.

Emergency communication pull should be within reach of the toilet, with a red triangle positioned at 100mm, and between 800mm - 1000mm from the floor.

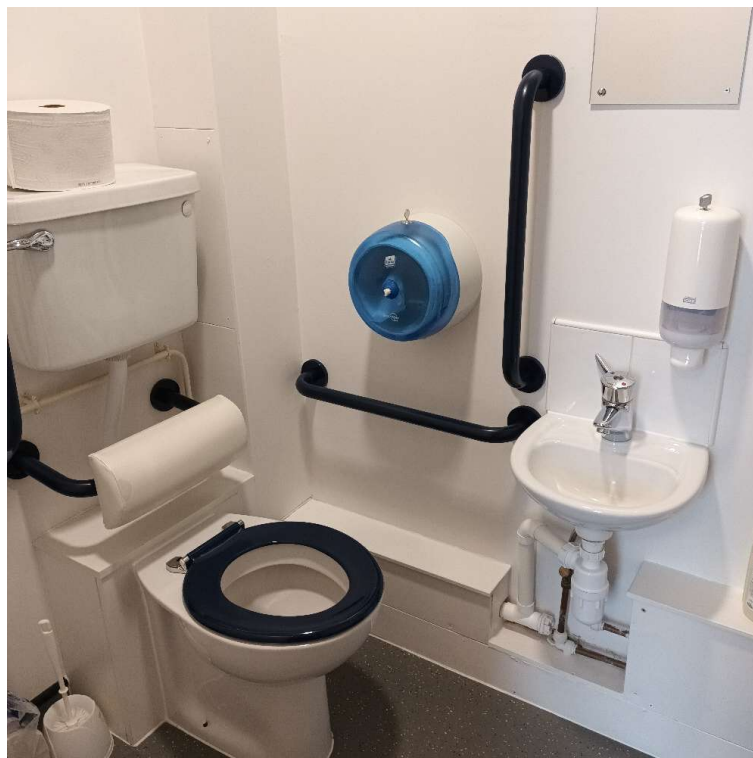
Fittings and consumables cannot be reached by person sitting on the toilet seat.

The sink, soap, toilet paper, and/or paper towels should be relocated to allow use whilst seated on the toilet.

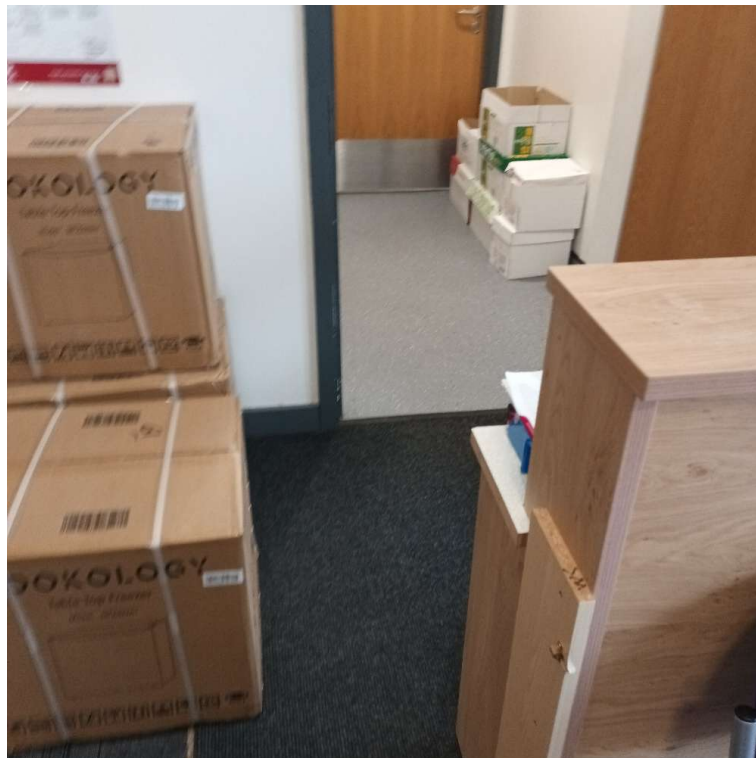
Traffic route to accessing toilet obstructed.
Remove obstructions.

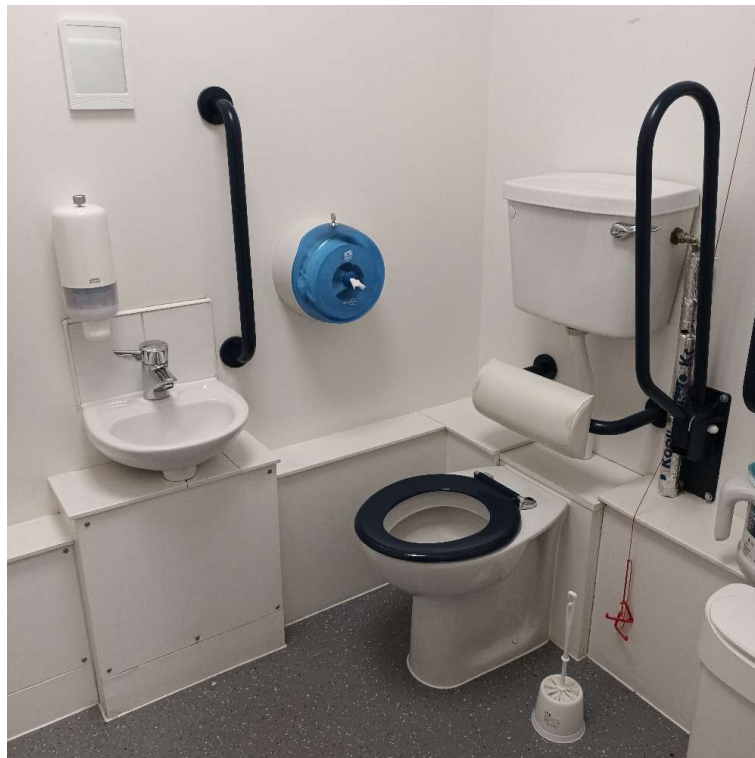
Fittings and consumables cannot be reached by person sitting on the toilet seat.

The sink, soap, toilet paper, and/or paper towels should be relocated to allow use whilst seated on the toilet.

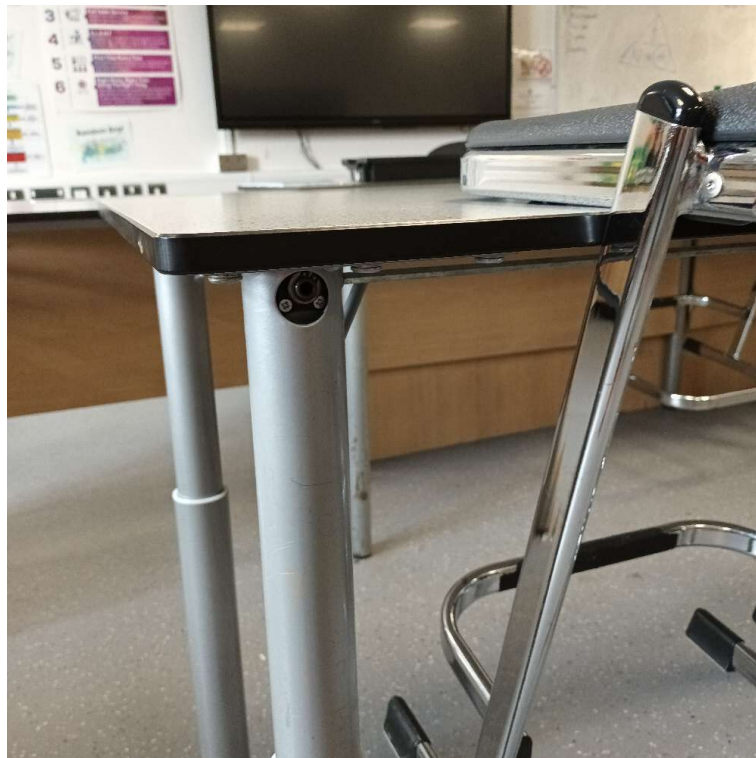
Adjustable table provided for pupil with mobility plan.

Handle to adjust missing, locate or purchase handle.

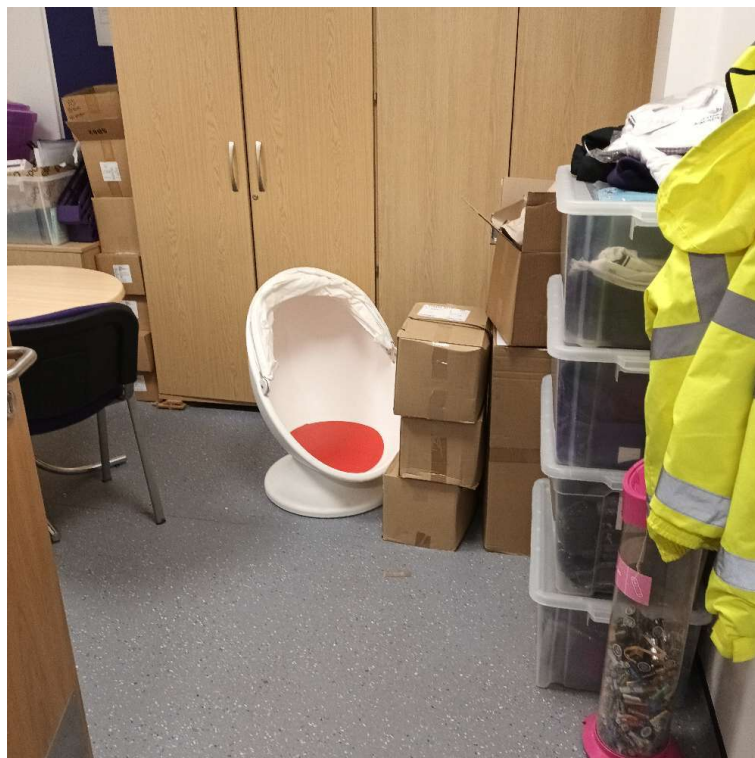
Medical room being used as a storage area.

Reassess and organise appropriately.

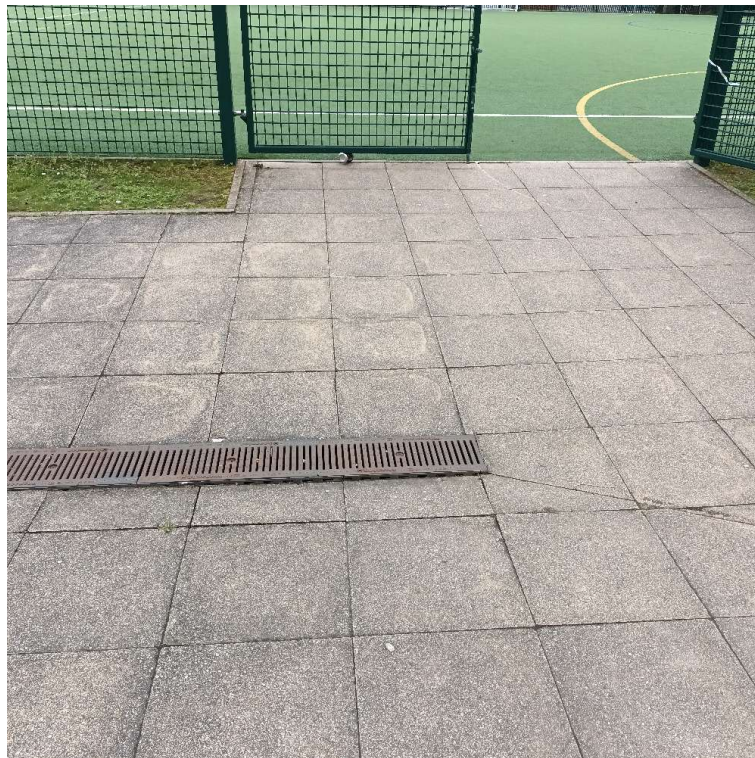
Pedestrian route is an uneven and/ or unsuitable surface.

Ensure surface is level and constructed of a firm, durable and slip resistant material.

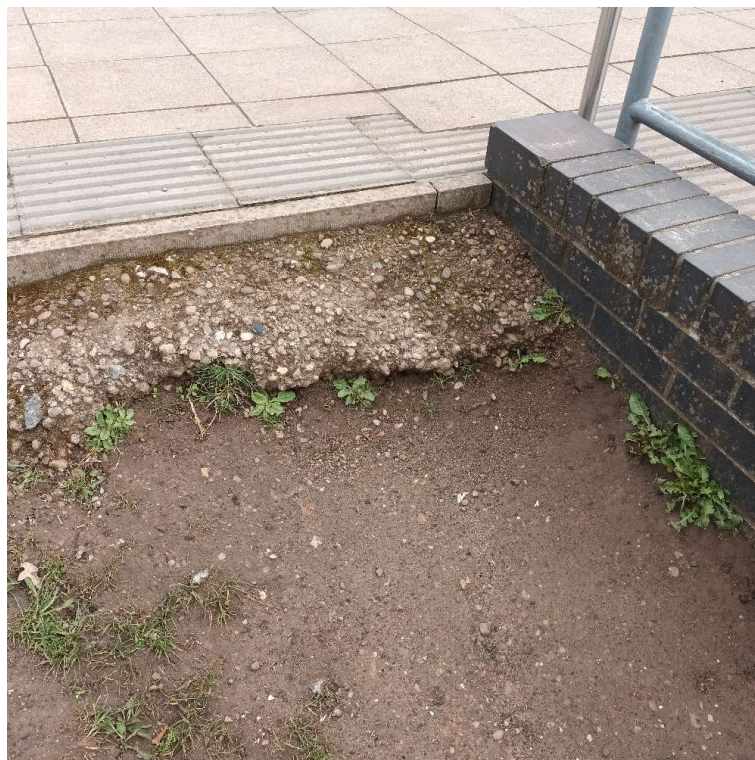
Pedestrian route is an uneven and/ or unsuitable surface.

Ensure surface is level and constructed of a firm, durable and slip resistant material.

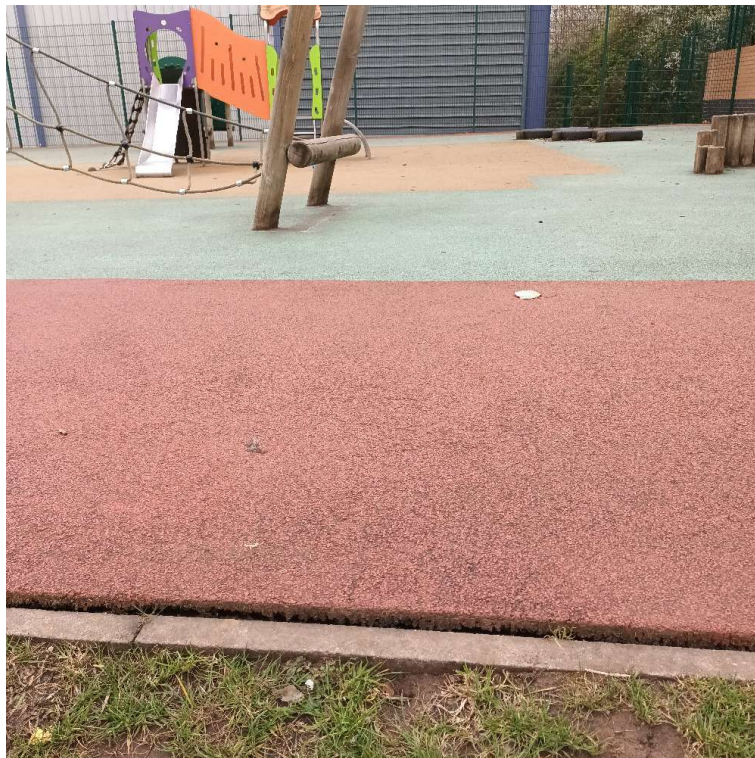
Pedestrian route is an uneven and/ or unsuitable surface.

Ensure surface is level and constructed of a firm, durable and slip resistant material.

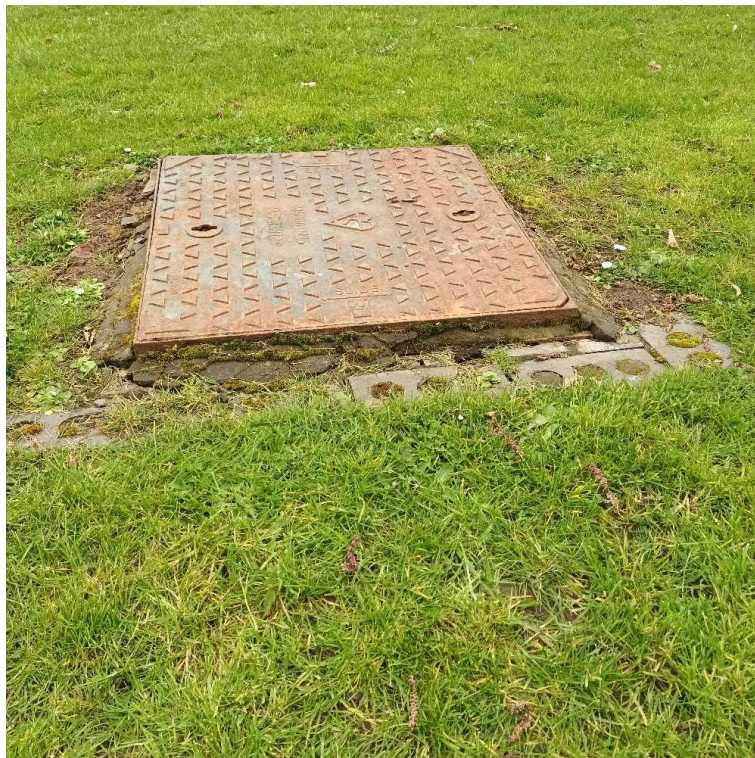
Pedestrian route is an uneven and/ or unsuitable surface.

Ensure surface is level and constructed of a firm, durable and slip resistant material.

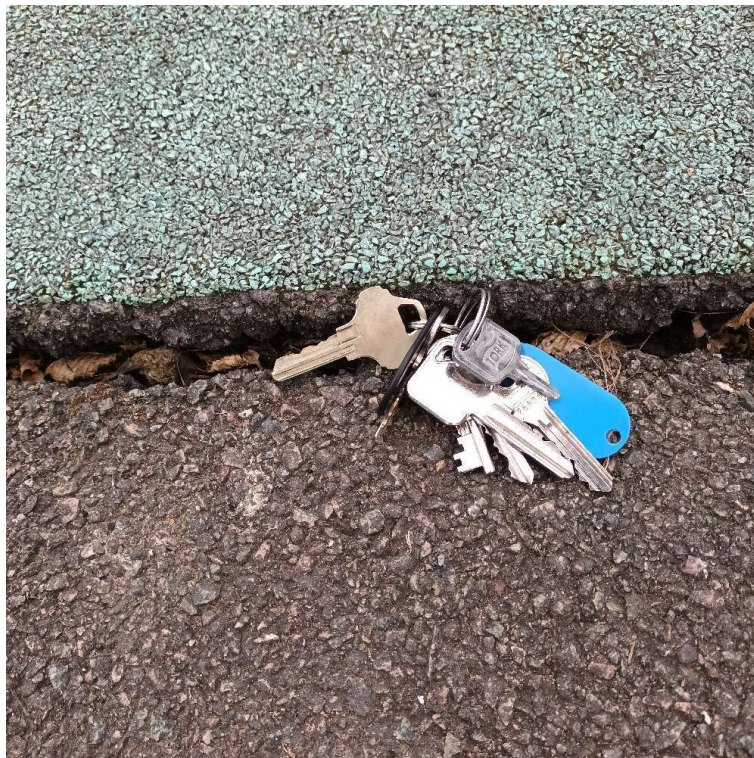
Pedestrian route is an uneven and/ or unsuitable surface.

Ensure surface is level and constructed of a firm, durable and slip resistant material.

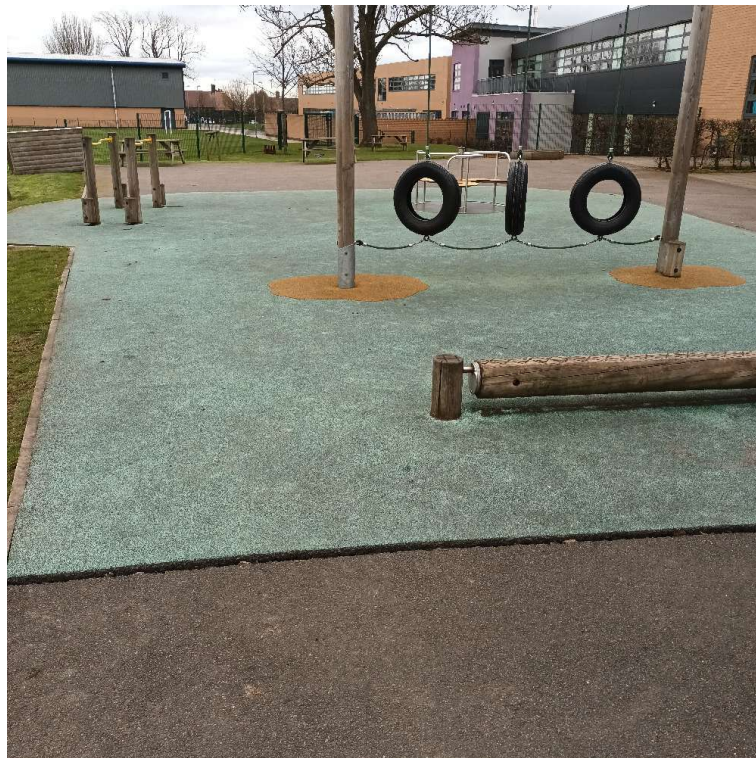
Pedestrian route is an uneven and/ or unsuitable surface.

Ensure surface is level and constructed of a firm, durable and slip resistant material.

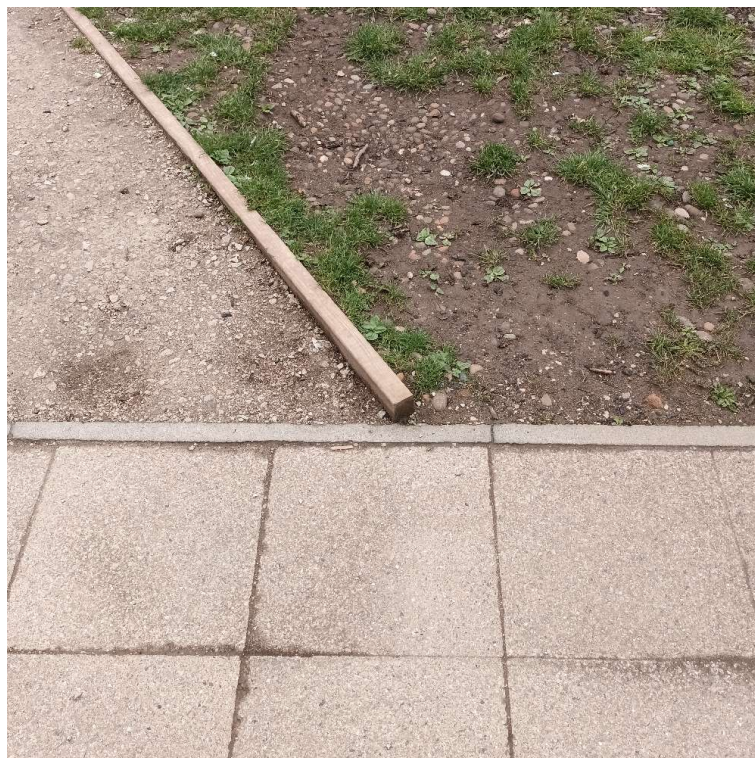
Pedestrian route is an uneven and/ or unsuitable surface.

Ensure surface is level and constructed of a firm, durable and slip resistant material.

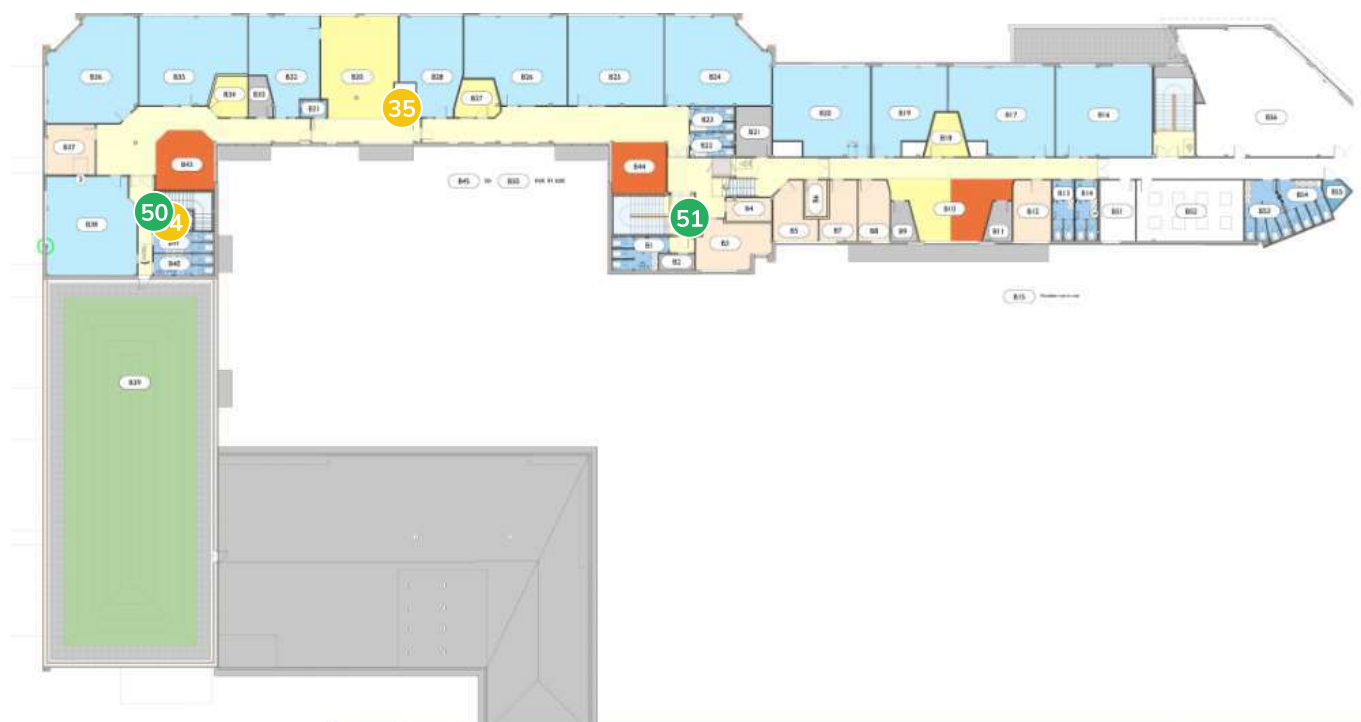
NAC - GR Primary Floor B

34 ● Accessible Toilets/Hygiene Rooms
35 ● Accessible Toilets/Hygiene Rooms
